# EMERGENCY ACTION PLAN

## FAWN LAKE DAM

Spotsylvania County, Virginia

Revision 14.1

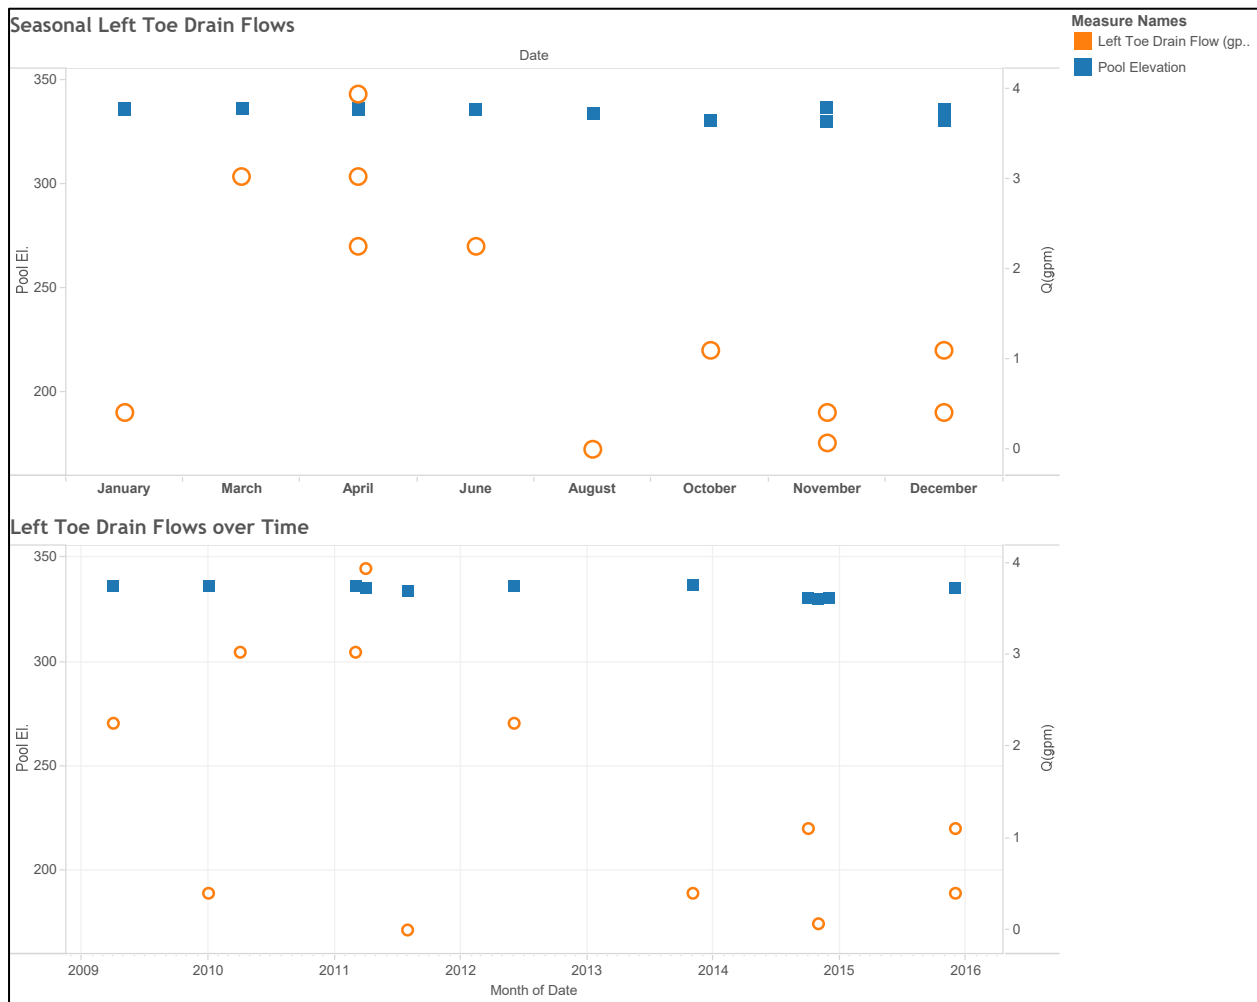
There is a weir box located to the left the principal spillway that measures the quantity of flow from the left toe drain and lake pool elevations. Flows outside these ranges are a potential indicated of a developing problem and should be addressed in a timely manner.

Note: There is also a weir on the right but we do not have seasonal flow data for it yet.

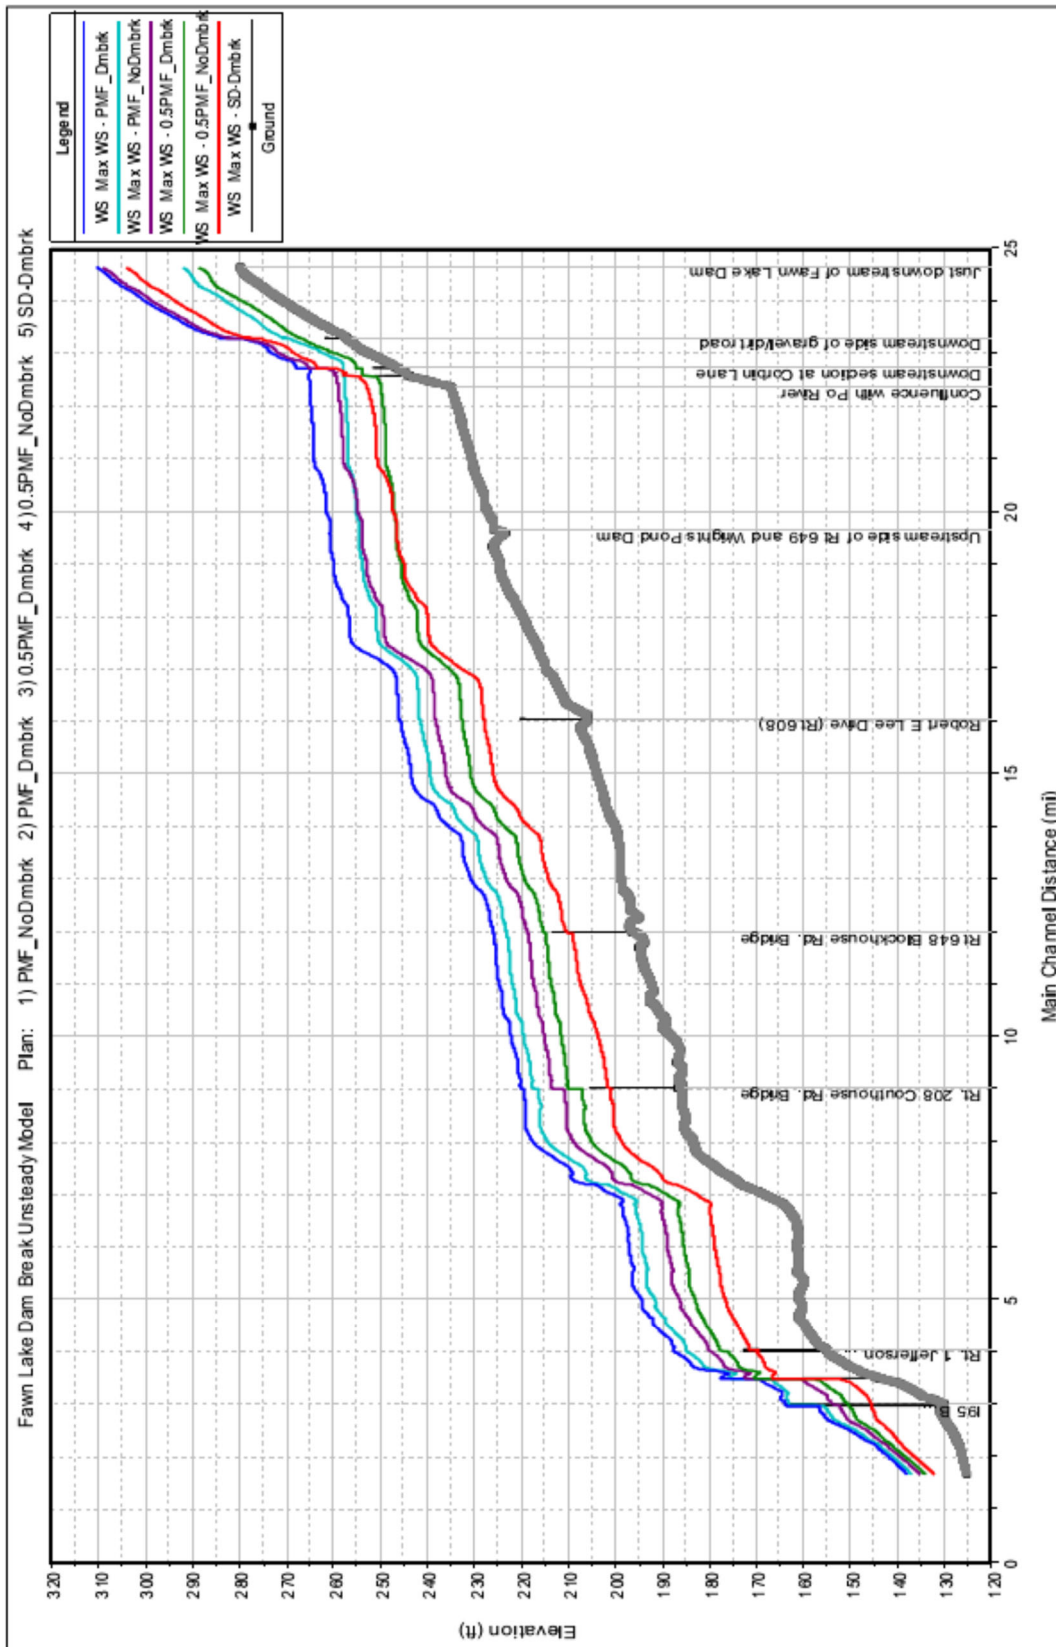
Figure 5. Maximum Water Surface Elevation Profiles.

### Appendix H – Flood Depths

The analysis extended from the Fawn Lake Dam to a point just approximately 1.6 miles downstream of Interstate 95 and approximately 1.6 miles upstream of the confluence of the Po and Ni Rivers. The inundation zone ends approximately 14 miles downstream of the dam at the confluence of the Po and Ni Rivers. Inundation maps showing the area that would be inundated by a sunny day breach and a PMF breach as well as failure flood profiles for the floodplain are included in Appendix G.

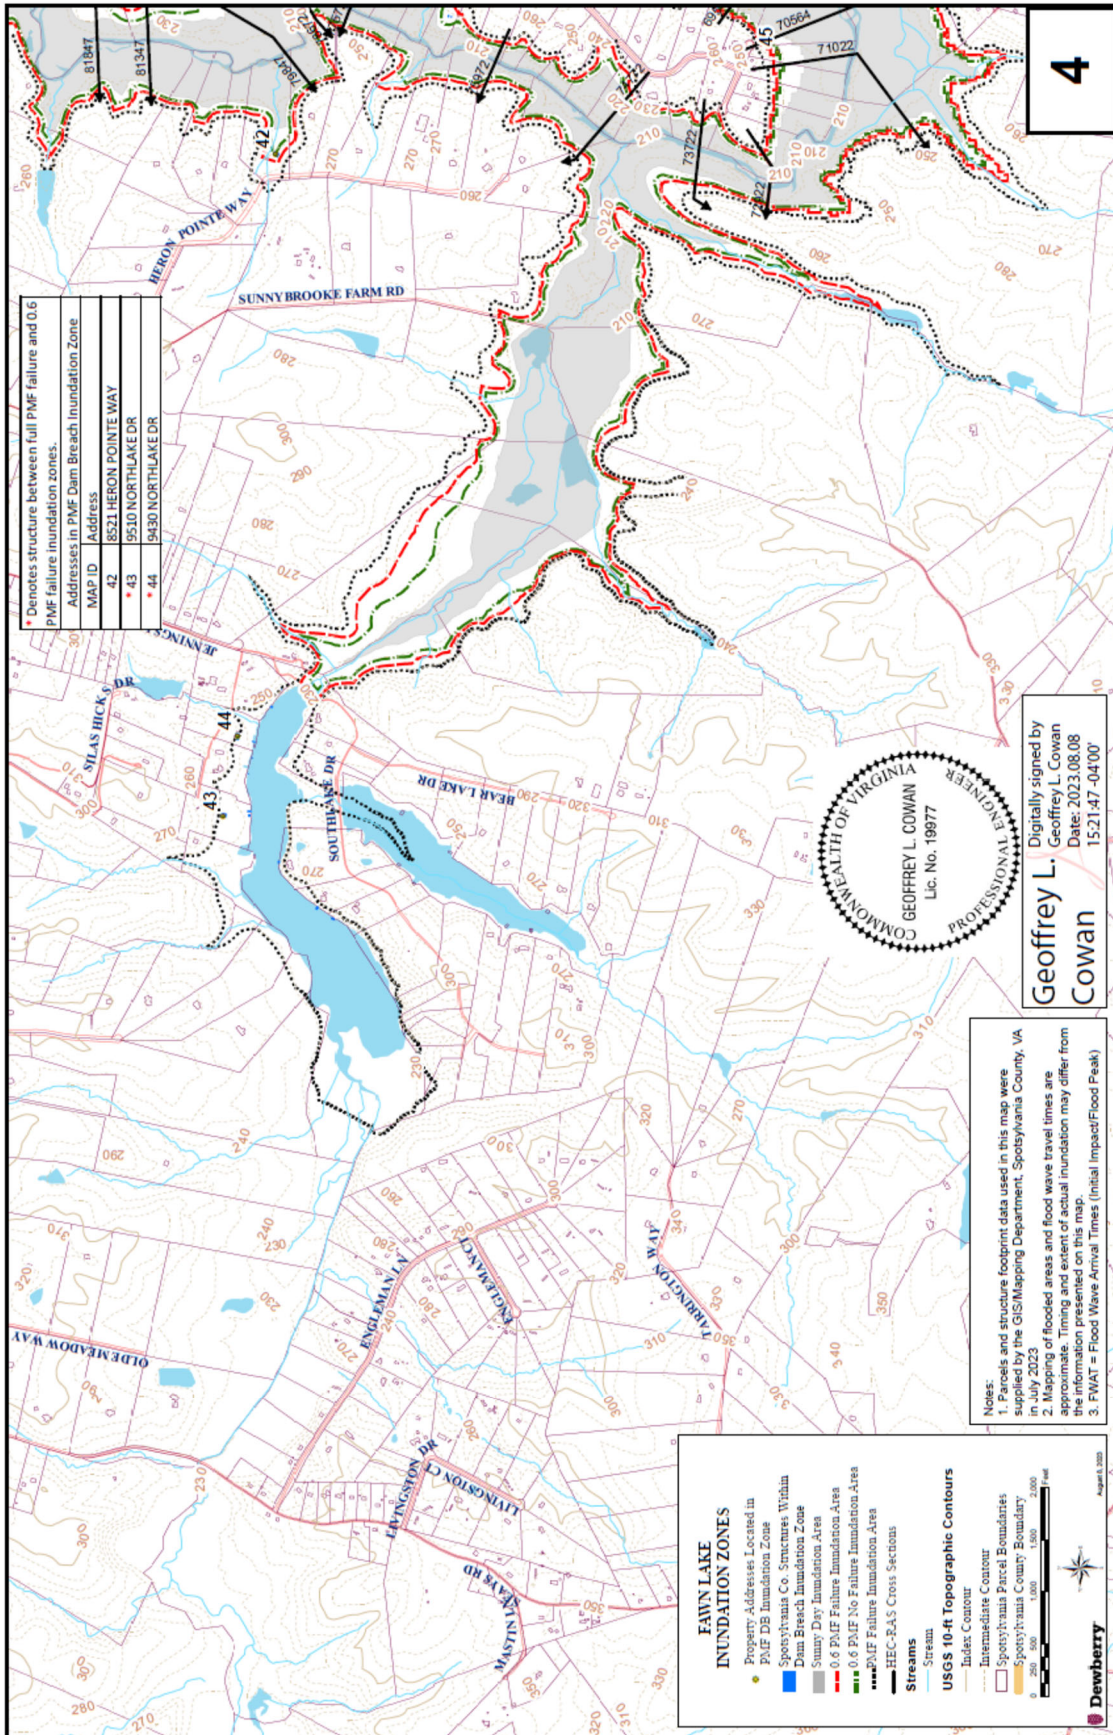
## **Appendix J – Inundation Maps**

The inundation maps were updated in August 2023 as part of the six-year update cycle.

A breach analysis of the Fawn Lake Dam and a mapping of the downstream inundation zone were completed by Dewberry & Davis in March of 2010. A breach analysis is the modeling of how a breach of the embankment would affect the downstream floodplain. It considers the volume in the reservoir, the physical dimensions of the embankment, and the topography of the downstream floodplain. This model is used to determine the area which would be inundated if the embankment were to breach under several scenarios ranging from a “sunny day” failure where the embankment fails due to internal erosion to an overtopping of the embankment during a “probable maximum flood” (PMF). It should be noted that actual storms will vary from this design standard in duration and intensity. The area that is flooded (or inundated) due to these scenarios is mapped and presented as an inundation zone map.
